# Pavement Technology, Inc.

# Reclamite Maltene Based Rejuvenator

## A DATA-DRIVEN CONDITION ASSESSMENT

FOR ASPHALT REJUVENATION USING  
MALTENE REPLACEMENT  
TECHNOLOGY

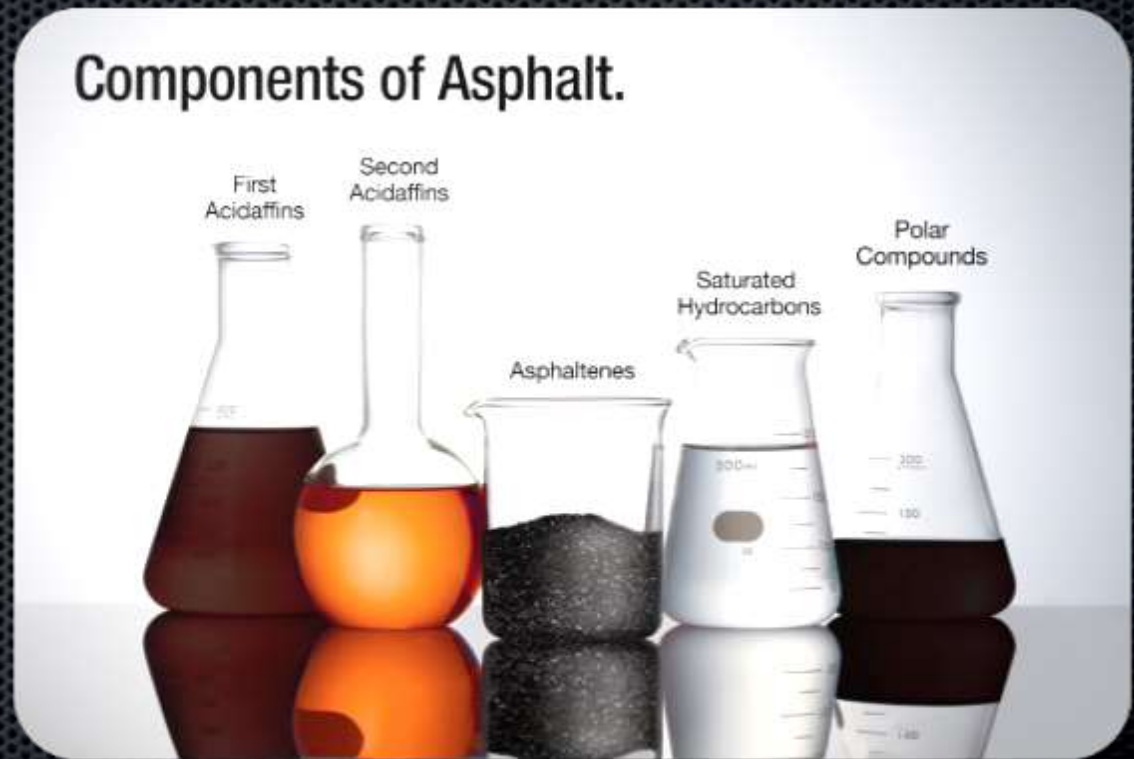
Asphalt cement consists of two main groups, Asphaltenes and Maltenes

**Asphaltenes:** provide body and color. They are brittle like pencil lead, not effected by oxidation.

**Maltenes:** provide the stickiness and adhesive properties, are highly susceptible to oxidation.

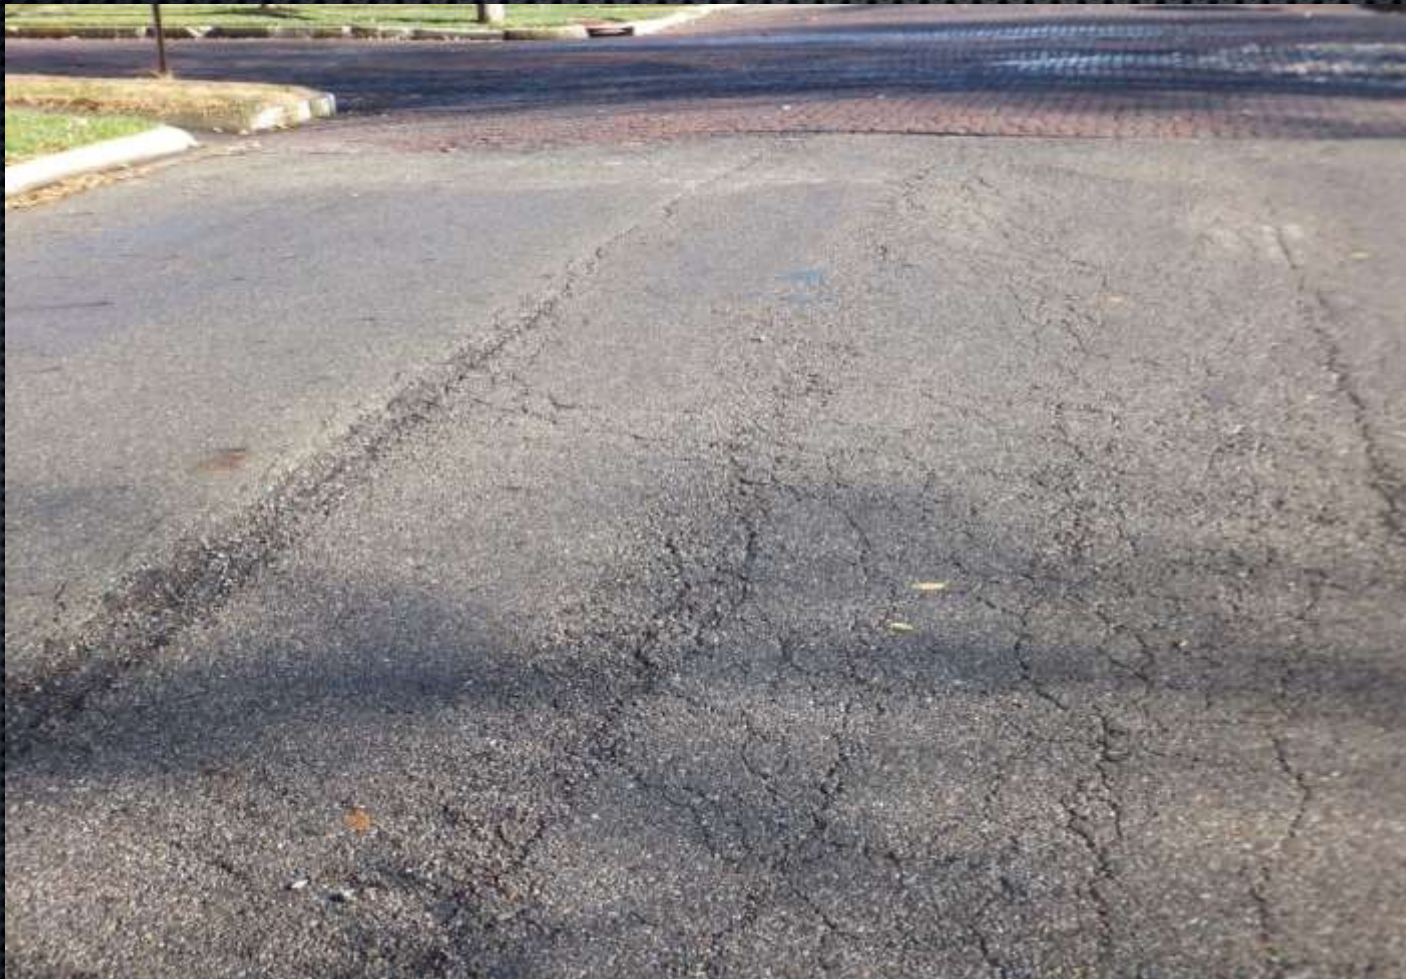
The reactive components oxidize causing an imbalance that increases asphaltenes

Penetrates 1/4" into the asphalt

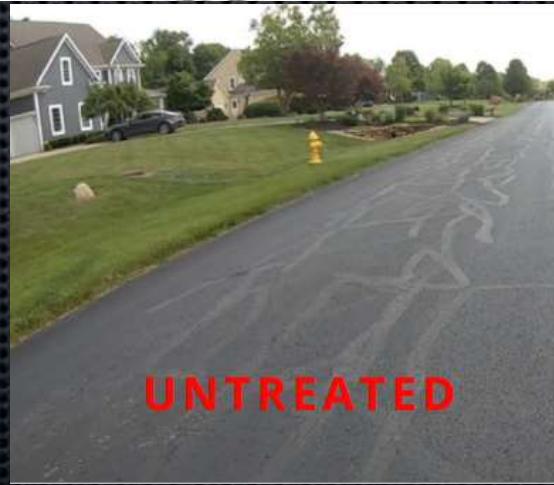
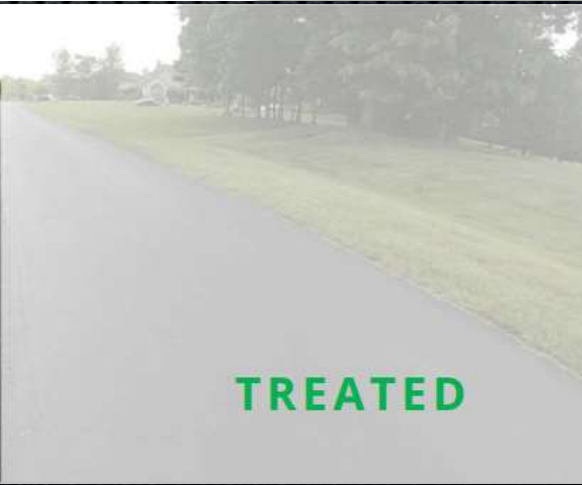
The untreated lane shows noticeable longitudinal and transverse cracking that has been treated with a crack seal since being paved in 2013. Furthermore, you can see signs of raveling throughout 10% of the surface, and weathering throughout 100% of the surface.

After documenting these distresses within the PAVER® pavement management system, the PCI of the untreated lane is a 70.

The treated lane shows that while longitudinal and transverse cracking is visible, it has just started to form and take shape. Furthermore, there are no signs of raveling within the treated surface, with light severity weathering only present within 20% of the surface.

After documenting these distresses within the PAVER® pavement management system, the PCI of the treated lane is 84.

Based upon the age of each pavement and PCI calculated from the ASTM D6433 condition assessment, the untreated locations lost an average of 3.5 PCI points per year, while the treated locations lost an average of just 1.5 points per year; resulting in a 2 point PCI gain.

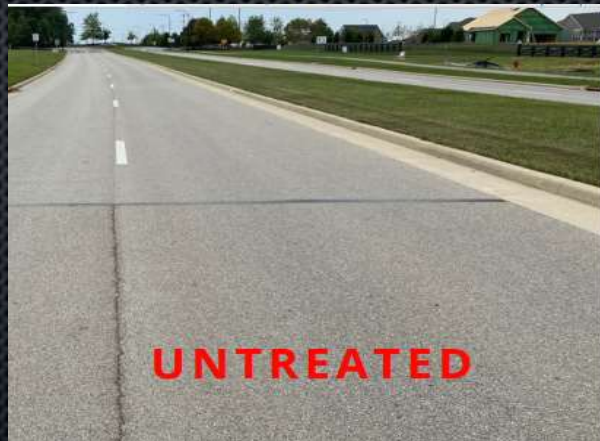
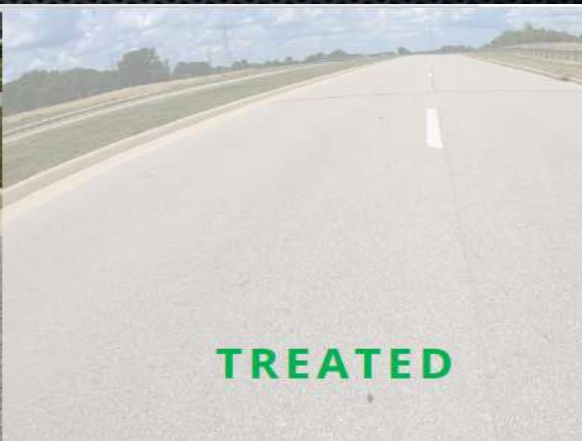
The untreated segment shows noticeable light and medium severity longitudinal cracking along the paving joint with light severity weathering present throughout 100% of the surface.

After documenting these distresses within the PAVER® pavement management system, the PCI of the untreated segment is 85.

The treated segment shows minimal, light severity longitudinal cracking along the paving joint, with light severity weathering present throughout just 50% of the surface.

After documenting these distresses within the PAVER® pavement management system, the PCI of the treated segment is 95.

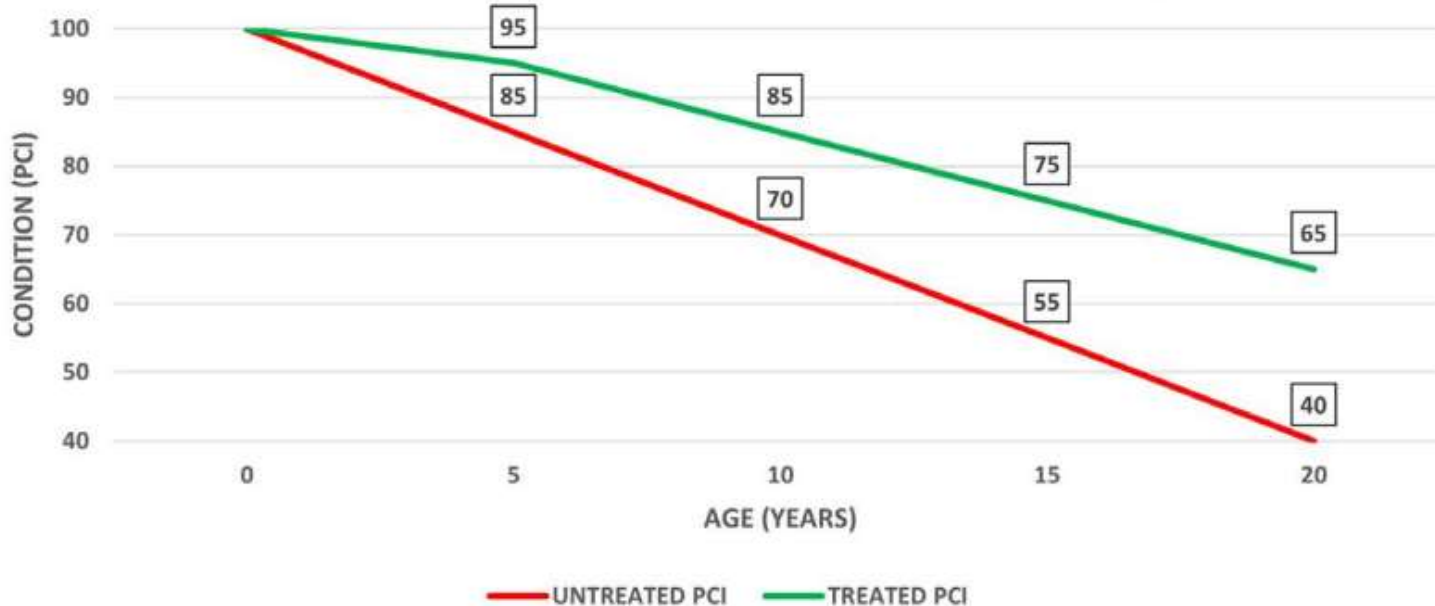
**PAVEMENT LIFECYCLE  
UNTREATED VS TREATED**

It is within my professional opinion that an MRT application within the first three (3) years of an asphalt pavement's life will extend the life by up to an additional five (5) years, as shown in the below performance curves created directly from the aggregated data documented within this report.

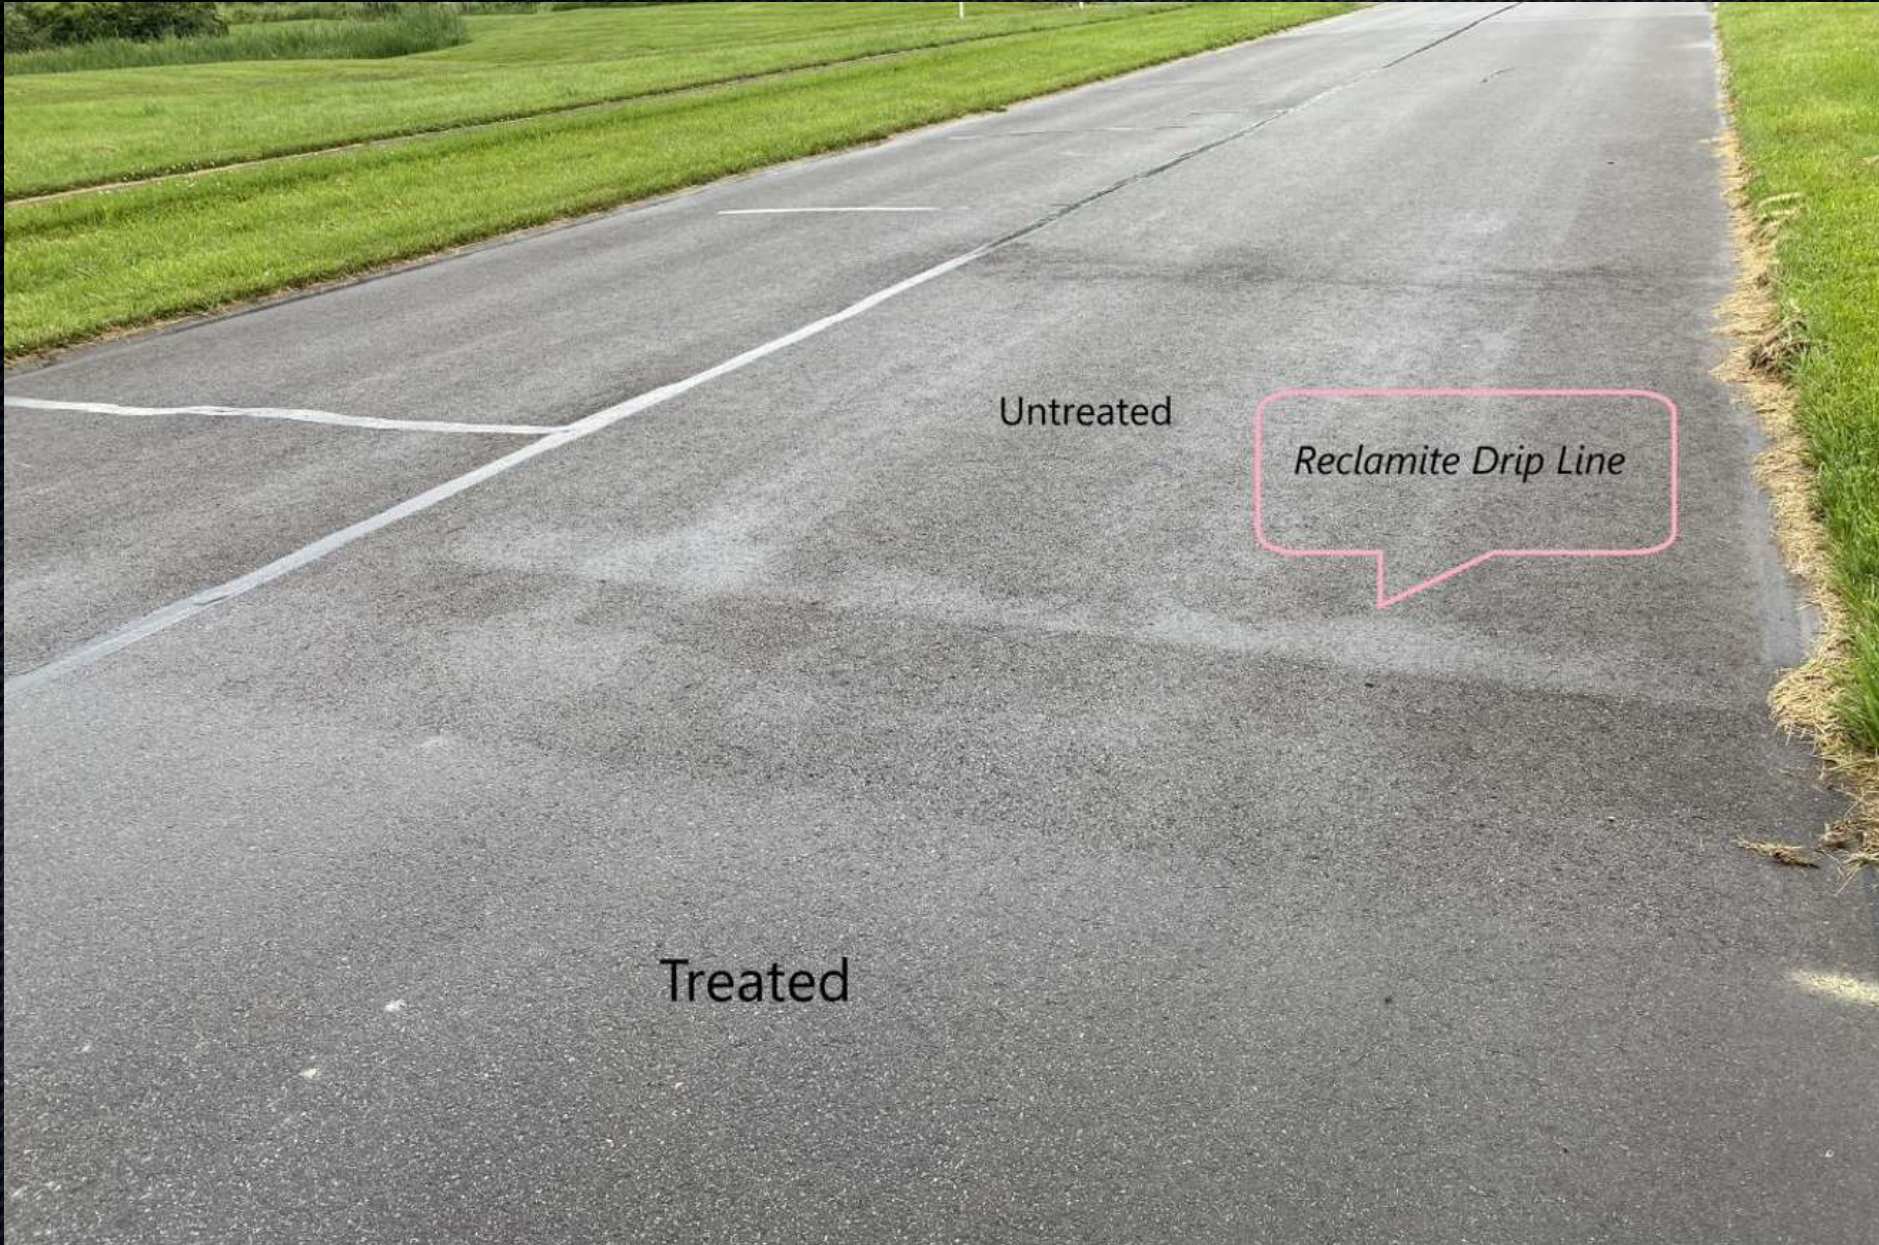
# 2021 after a Rain

*Reclamite Drip Line*

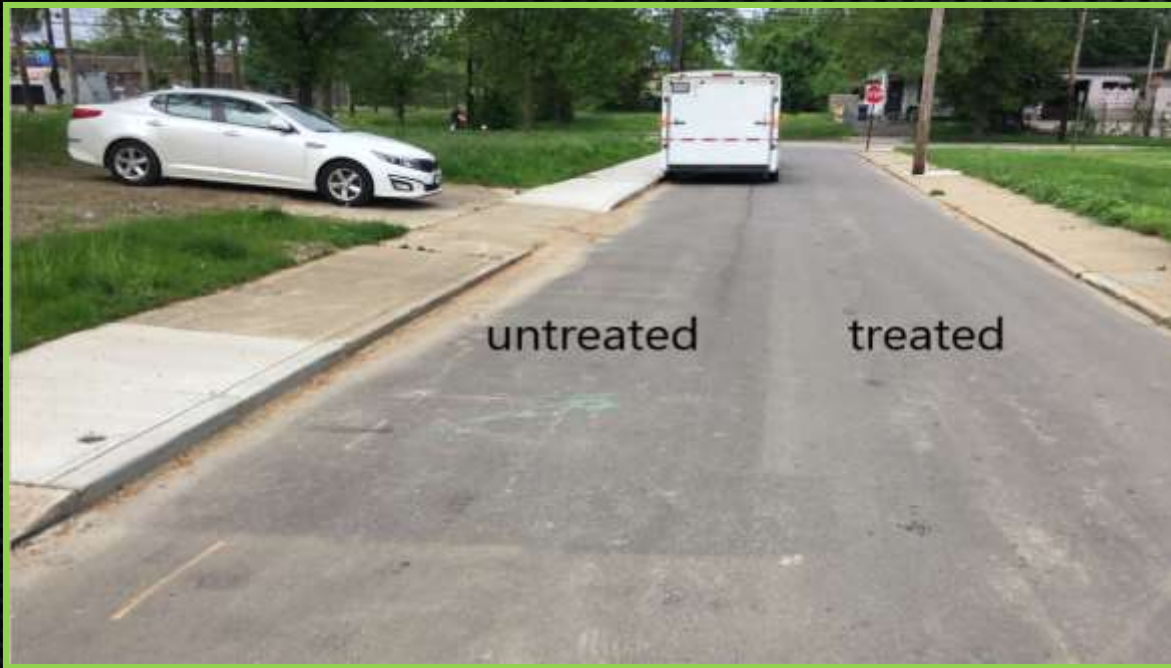
Reclamite is providing a visible seal on Rogers rd. Picture 1 is during a dry day and picture 2 is about 30 minutes after rain.

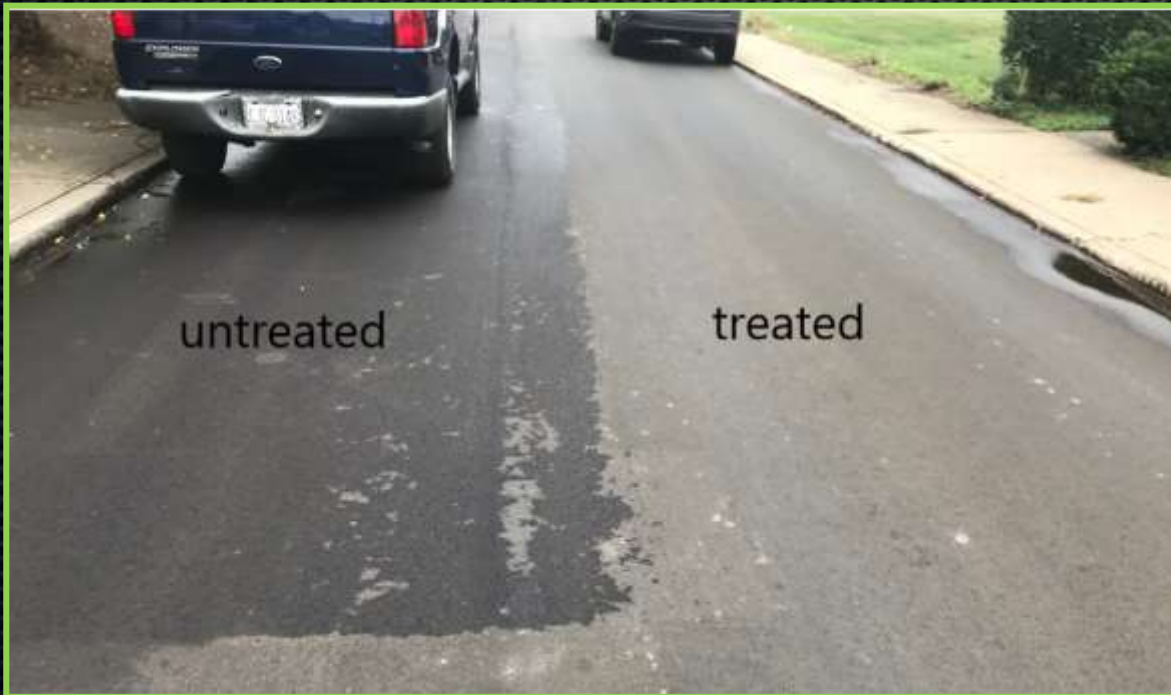
Water collects in just the untreated area due to voids in the surface. Treated portion of rd. is tighter and sheds moisture. This is a great example of how Reclamite can help fight against tree canopy as well.

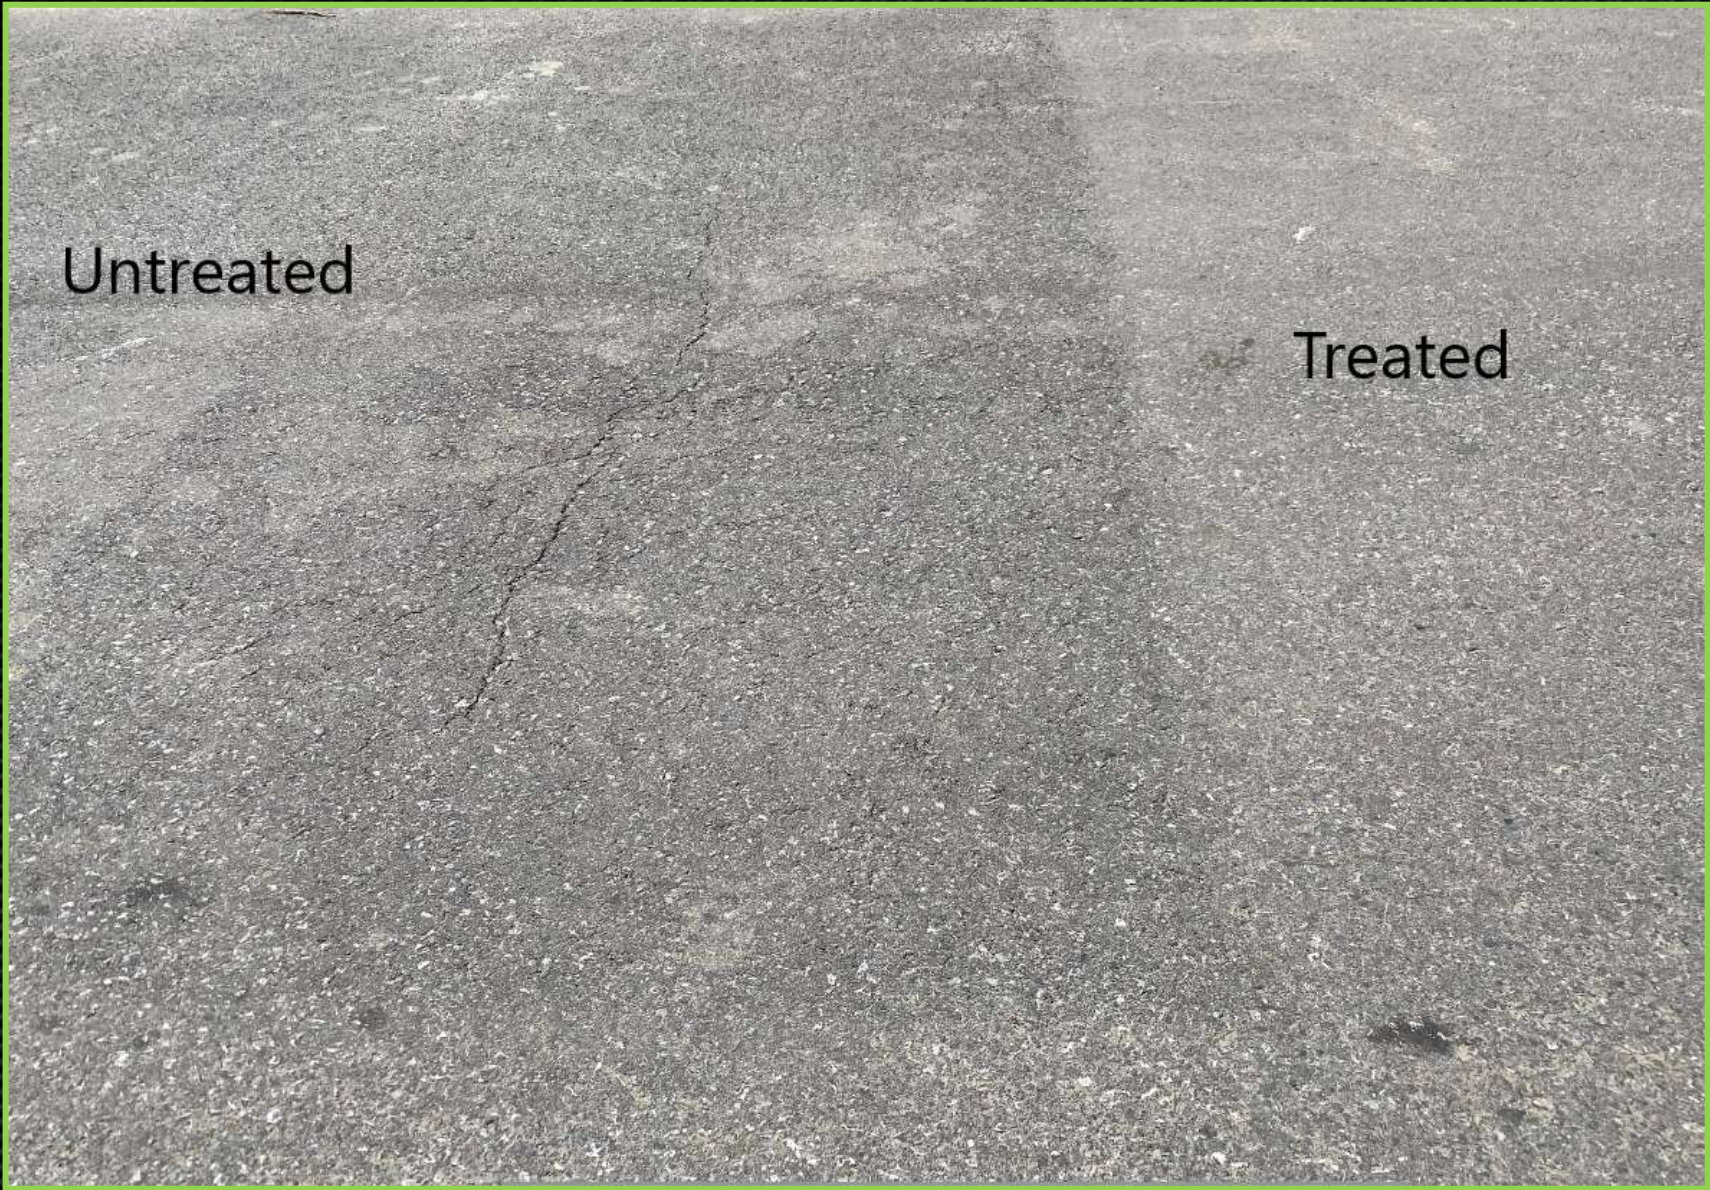
Closer look reveals slight surface cracking in untreated area vs treated section. Pitting is also more evident.

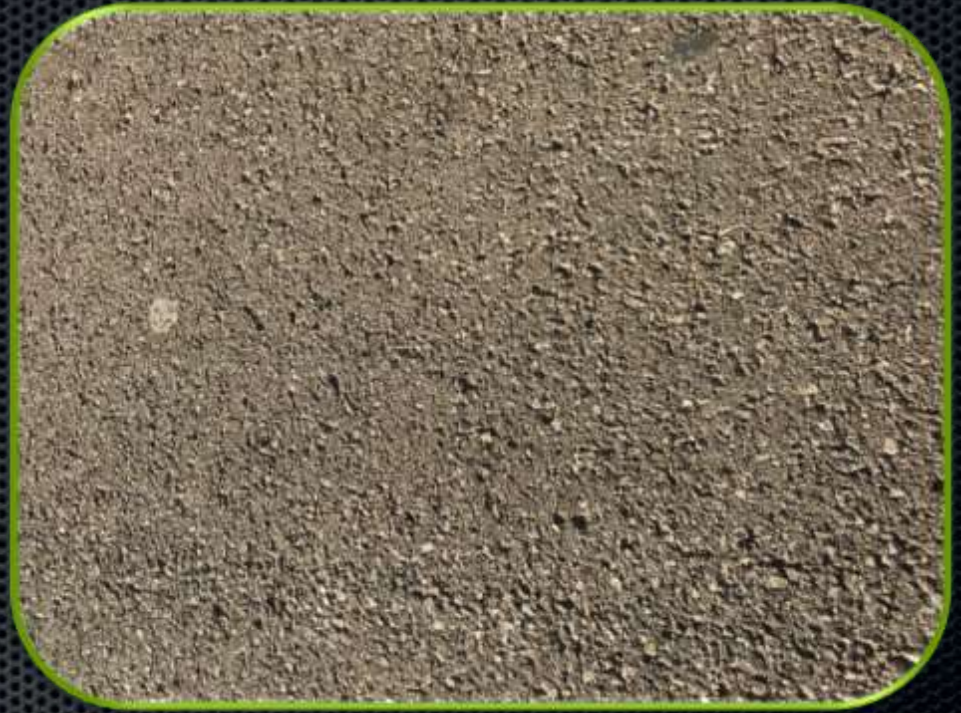
Early Pitting of asphalt
